**Flood Control Project Maintenance  
Levee Inspections**

**Fall 2019 Levee Maintenance Deficiency Summary Report**

<b>RD0349</b>	Overall LMA Rating	Total LMA Miles						
<b>Reclamation District No. 0349 Sutter Island</b>	<b>U</b>	<b>12.41</b>						
Rated Item	Maintenance Deficiency				Enforcement		Design & System Obsolescence	
	M Miles	U Miles	M + 4U Miles	Threshold %	M Miles	U Miles	M Miles	U Miles
<i>Earthen Levee</i>								
Vegetation	5.48	3.84	20.84	167.97%	0.14	0.57		
Trim / Thin Trees	0.26	0.04	0.42	3.39%				
Encroachments	0.24		0.24	1.93%	1.04	0.29		
Animal Control	0.18		0.18	1.45%				
Slope Stability	0.01		0.01	0.08%				
Crown Surface / Depressions / Rutting	0.01		0.01	0.08%				
Flood Preparedness & Training	0.12		0.12	0.97%				
<i>Supplemental</i>								
2017 USACE Erosion Survey	0.35		0.35	2.82%				
DRAFT DWR UCIP Field Study					0.50	0.01		
2017 Storm Damage	0.22		0.22	1.77%				
<i>LMA Totals:</i>	6.87	3.88	22.39	180.46%	1.68	0.87	0.00	0.00

**Flood Control Project Maintenance  
Levee Inspections****LMA District Cover Sheet  
Fall 2019 Levee Inspection Results****Reclamation District No. 0349 Sutter Island**

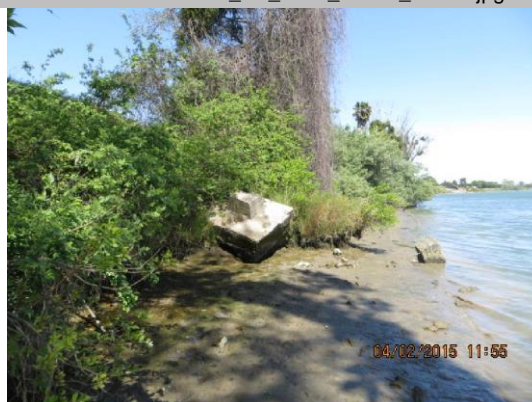
Photo 2 of 3 : UCIP\_FA\_2019\_44303\_73621.jpg

Concrete debris on WS toe is a good indicator of pump location.

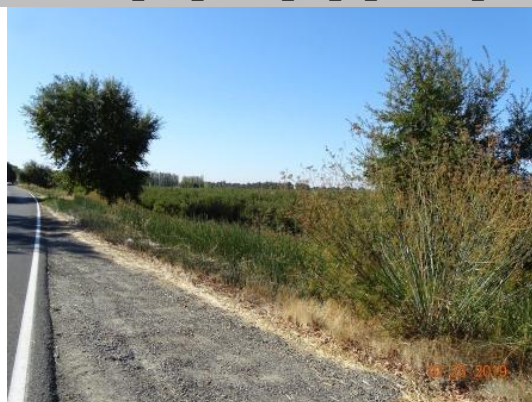
Photo 1 of 1 : FA\_2019\_RD0349\_204\_11\_20191025\_00031.jpg

View looking downstream at thick vegetation on the landside slope (Fall 2019).

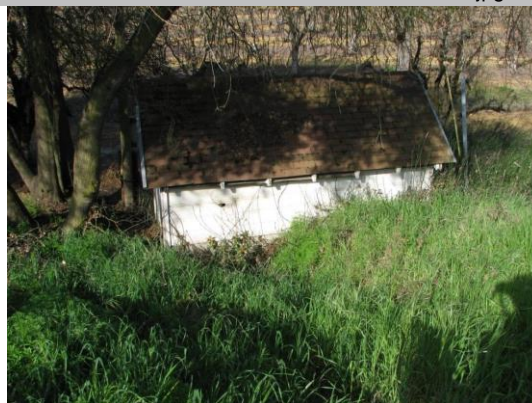
Photo 2 of 3 : UCIP\_FA\_2019\_21572\_36573.jpg

Pump house located on landward side at toe.

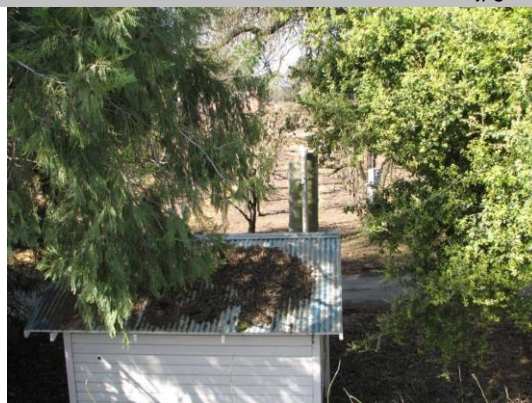
Photo 3 of 3 : UCIP\_FA\_2019\_50013\_36556.jpg

View of LS: pump house, concrete stand pipe, and electric pole.

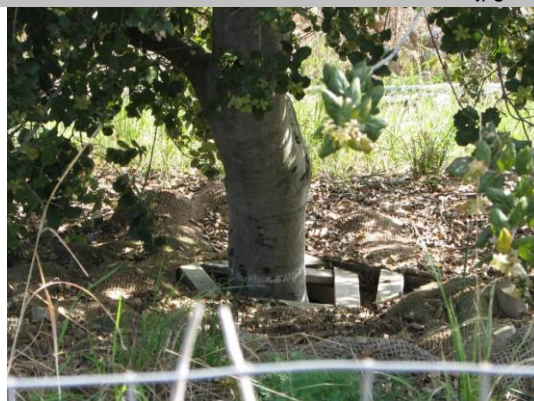
Photo 1 of 3 : UCIP\_FA\_2019\_44304\_36580.jpg

Geotech fabric and protective frame at tree--design features of erosion repair site 2007-2009.

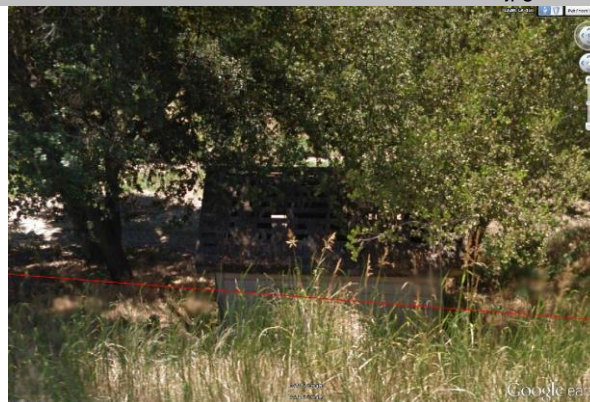
Photo 2 of 3 : UCIP\_FA\_2019\_44304\_73625.jpg

Pumphouse on LS toe (From google view)

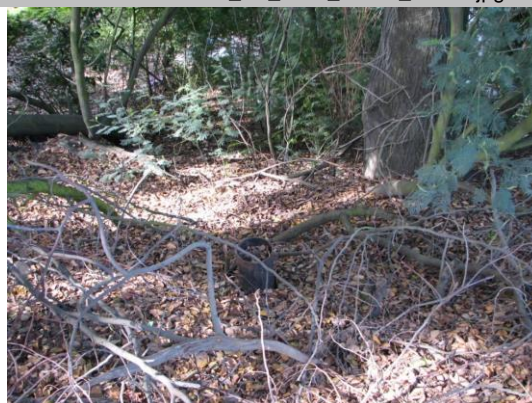
Photo 2 of 3 : UCIP\_FA\_2019\_44214\_36571.jpg

Pipe located on landward side--unable to determine whether it belongs to crossing.

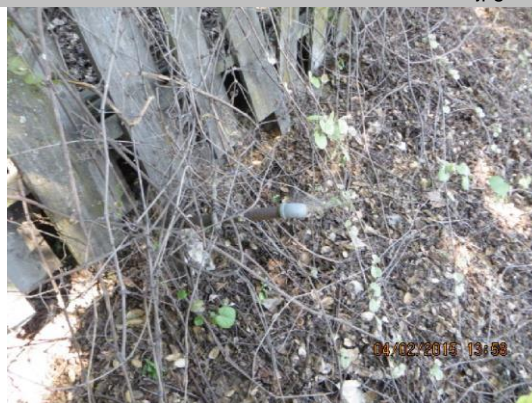
Photo 1 of 3 : UCIP\_FA\_2019\_46169\_74545.jpg

Pipe visible at base of fence on WS shoulder.

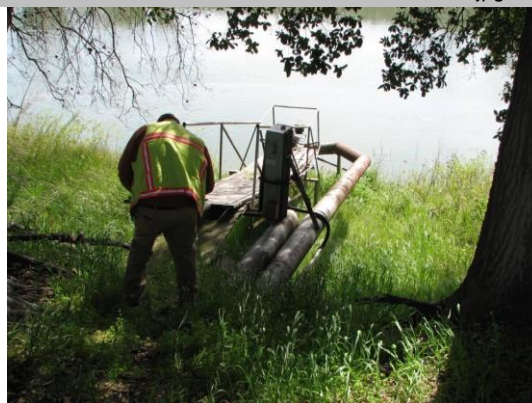
Photo 1 of 3 : UCIP\_FA\_2019\_21576\_36593.jpg

Dense vegetation on waterward slope--2 pipes and 1 conduit.

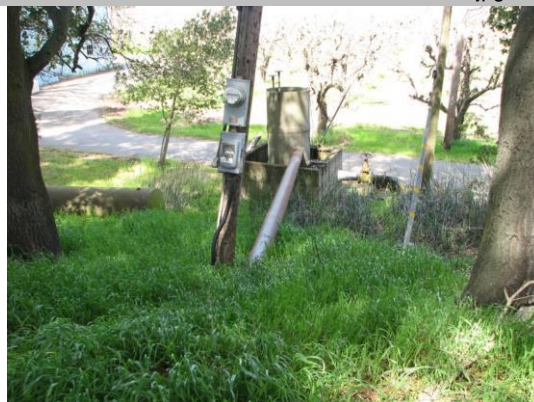
Photo 3 of 3 : UCIP\_FA\_2019\_21576\_36591.jpg

Multiple appurtenances found on landward side-standpipe, electrical pole, valve, concrete distribution box.

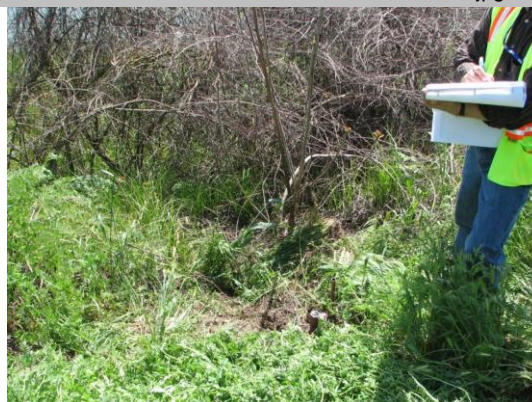
Photo 3 of 3 : UCIP\_FA\_2019\_21613\_36688.jpg

View of air valve located on waterward slope--dense vegetation limits inspection.

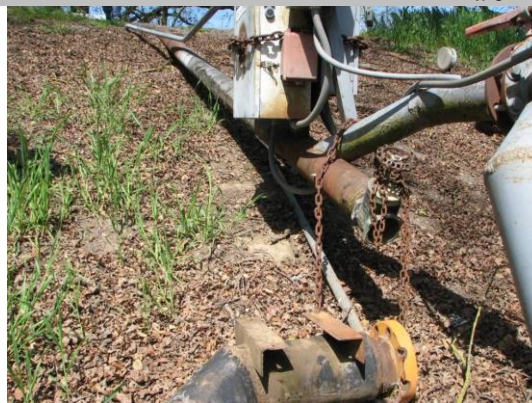
Photo 2 of 3 : UCIP\_FA\_2019\_21614\_36690.jpg

Crossing has been altered--abandoned pipe through levee slope remains.

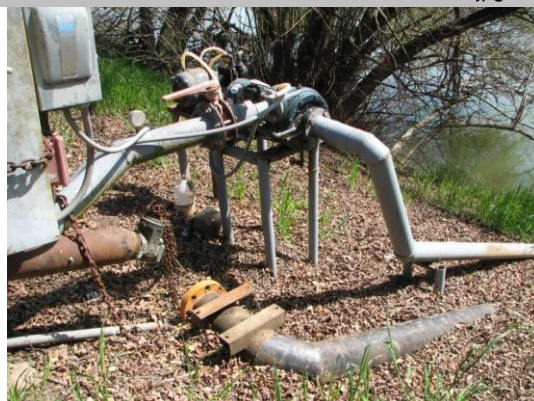
Photo 3 of 3 : UCIP\_FA\_2019\_21614\_36689.jpg

New configuration--sections of pipe have been abandoned.

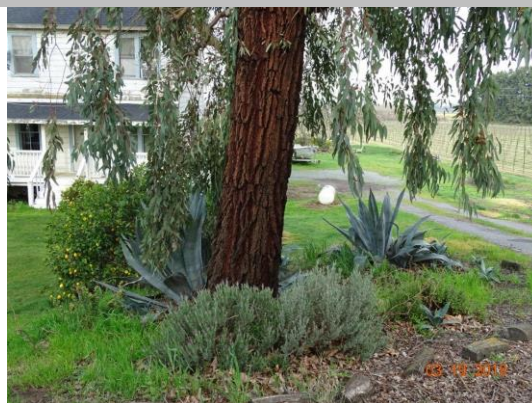
Photo 1 of 1 : FA\_2019\_RD0349\_205\_52\_20190826\_00038.jpg

View of cactus on the landside slope (Spring 2019).

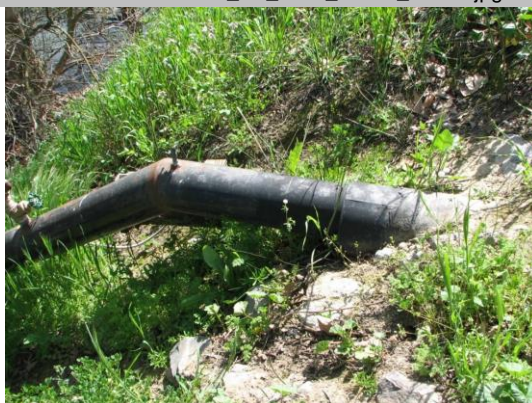
Photo 2 of 3 : UCIP\_FA\_2019\_21606\_36654.jpg

Smaller pipe sleeved through larger pipe that goes through levee.

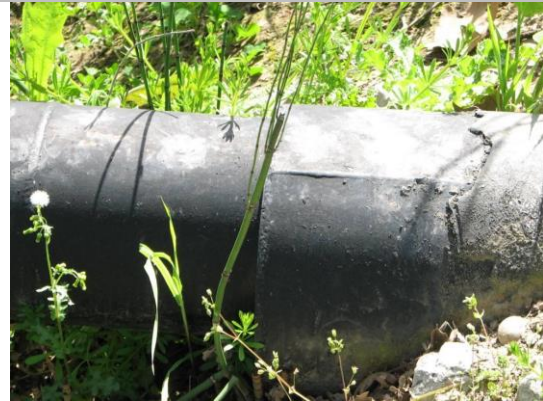
Photo 3 of 3 : UCIP\_FA\_2019\_21606\_36657.jpg

Pipe sleeved through larger pipe.

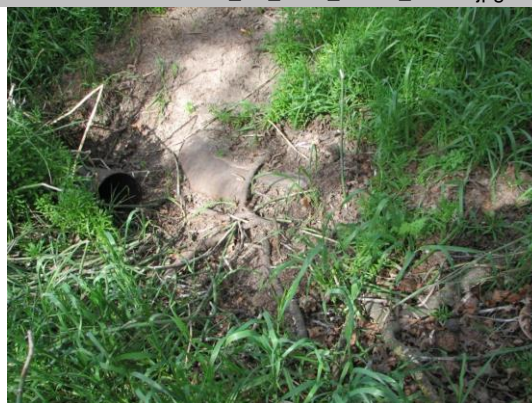
Photo 2 of 3 : UCIP\_FA\_2019\_21609\_36667.jpg

Debris along pipe alignment.

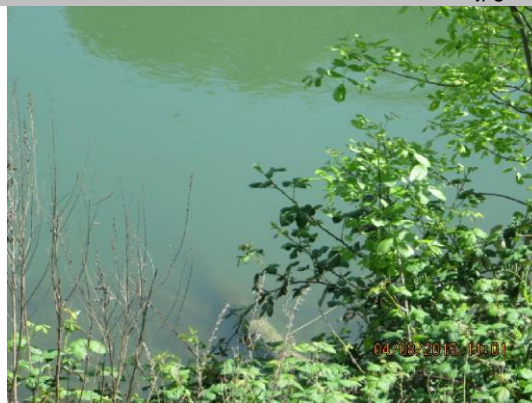
Photo 2 of 3 : UCIP\_FA\_2019\_44328\_73706.jpg

Pipe visible in water at WS toe.

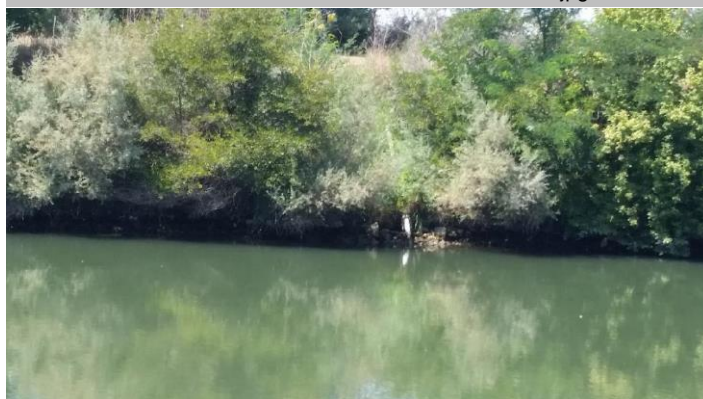
Photo 3 of 3 : UCIP\_FA\_2019\_53344\_75632.jpg

Pipe visible from opposite bank.

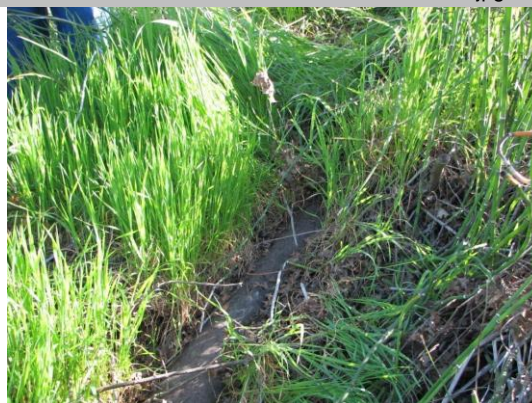
Photo 3 of 3 : UCIP\_FA\_2019\_43442\_36704.jpg

Pipe covered by dense vegetation.

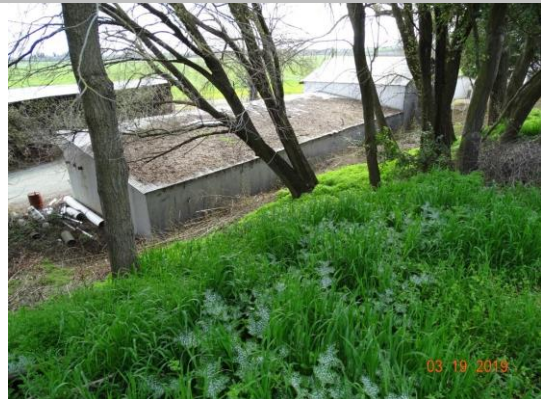
Photo 1 of 1 : FA\_2019\_RD0349\_206\_46\_20190826\_00008.jpg

View of building on the landside toe (Spring 2019).

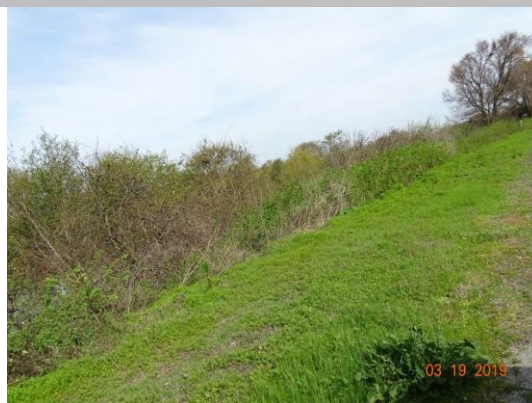
Photo 1 of 1 : FA\_2019\_RD0349\_206\_48\_20190826\_00010.jpg

View looking upstream at thick wild growth within 20 feet of the waterside shoulder (Spring 2019).

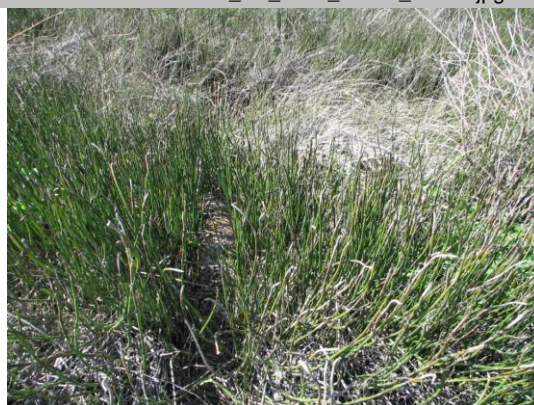
Photo 1 of 3 : UCIP\_FA\_2019\_43423\_36866.jpg

View of waterward side--dense vegetation covers slope.

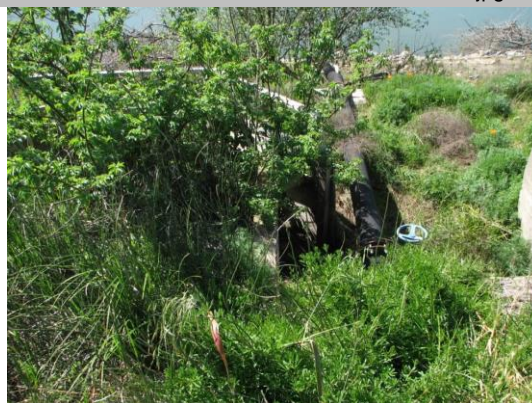
Photo 1 of 3 : UCIP\_FA\_2019\_43424\_36869.jpg

Waterward side--appears to be an erosion repair site. New pipe on waterward side and damaged pipe on landward side.

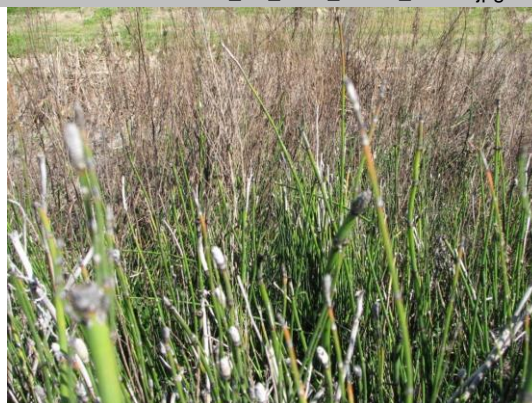
Photo 3 of 3 : UCIP\_FA\_2019\_43424\_36868.jpg

View of landward side--dense vegetation on slope limits inspection.

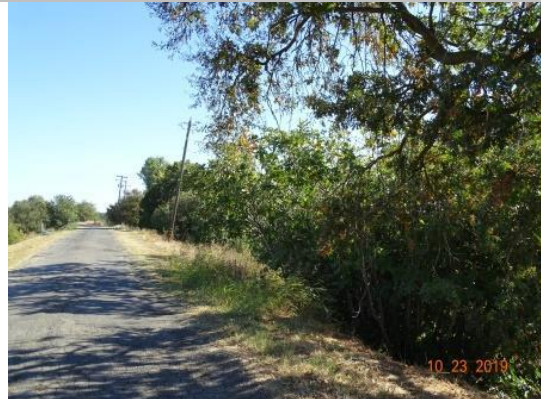
Photo 1 of 1 : FA\_2019\_RD0349\_206\_43\_20191025\_00096.jpg

View looking upstream at landscaping trees on the landside slope (Fall 2019).

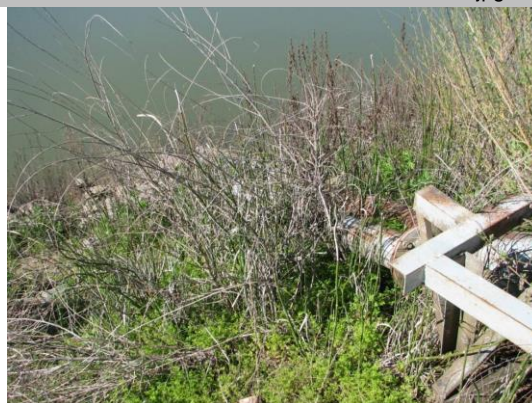
Photo 1 of 3 : UCIP\_FA\_2019\_43459\_36796.jpg

Waterward side--pipe visible through dense vegetation.
